Manhole Inspection Summary

Manhole # S35MM1006MH

Insp Date: **3/13/07 10:24 AM**

Location Address: **4418 EASTWAY**

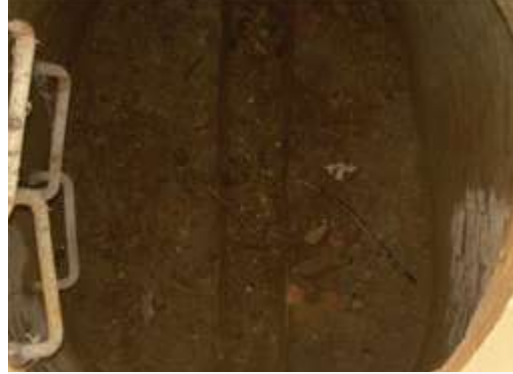
Top View

Bench and Channel debris.

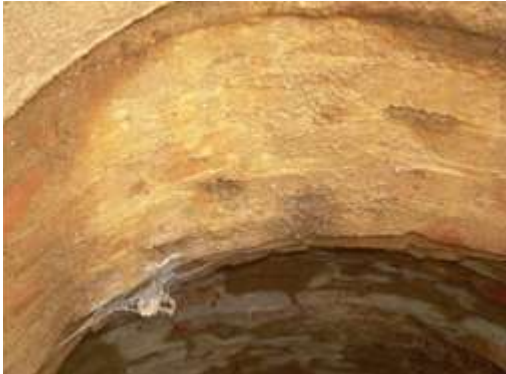
Defect

Frame leaks. Adjustment infiltration.
Barrel root intrusion and infiltration.

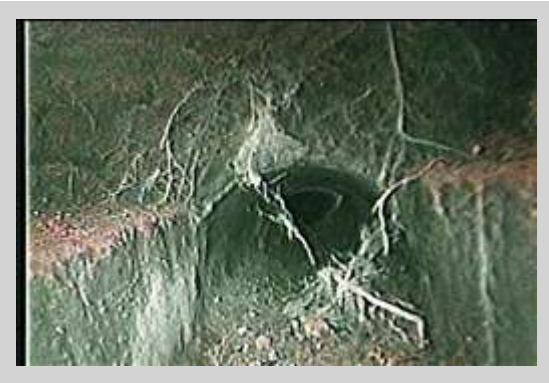
8 in. Circular Gravity Sewer Pipe Out @ 12 O'Clock

Barrel root intrusion and infiltration.

Deposits: ☐ None ☒ **Mud** ☐ Sludge ☒ **Debris** ☐ Grease

Silt Depth: **2** (in.) Deposits Extent: **Medium**

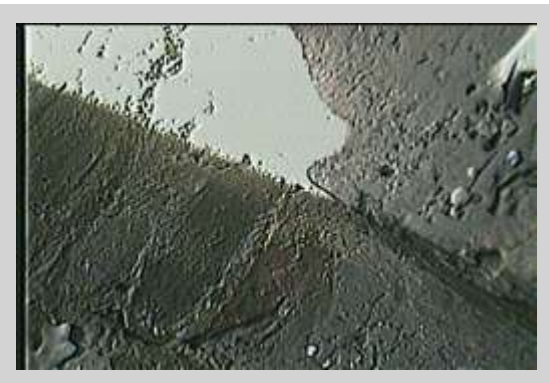
Pipe In @ 6 O'Clock

not really a stub there is only a wall there
